Manhole Inspection Summary

Manhole # S29EE_029MH

Location Address: **1322 MORRIS ST**

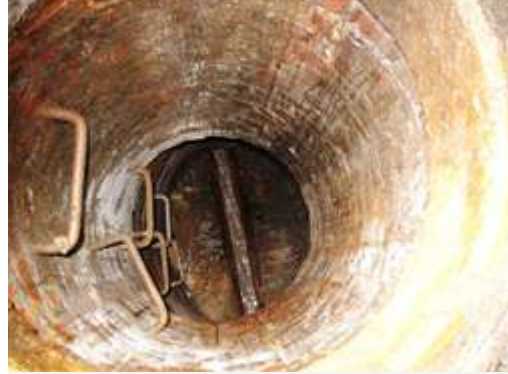
Top View

Frame leaks. Adjustment deterioration and infiltration. Barrel infiltration. Corroded steps. Evidence of surcharge -

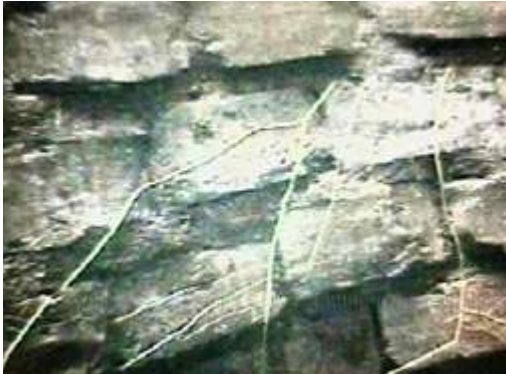
Defect

Barrel deterioration, root intrusion and infiltration.

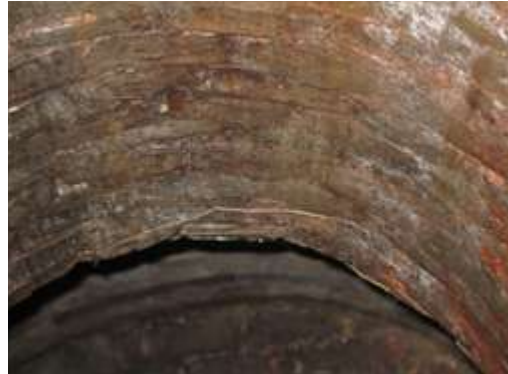
Defect

Corbel root intrusion and infiltration.

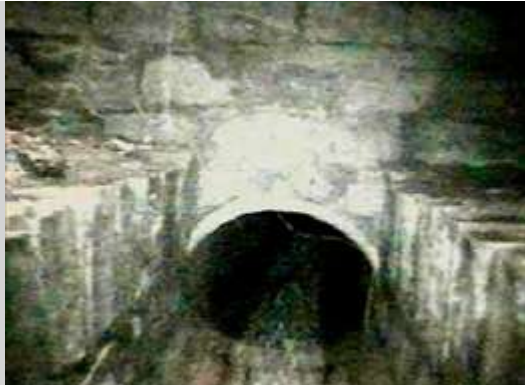
8 in. Circular Gravity Sewer Pipe Out @ 12 O'Clock

Deposits: ☐ None ☐ **Mud** ☐ Sludge ☐ Debris ☒ **Grease**

Infiltration: **Evidence** Pipe Seal Cond: **Unknown**

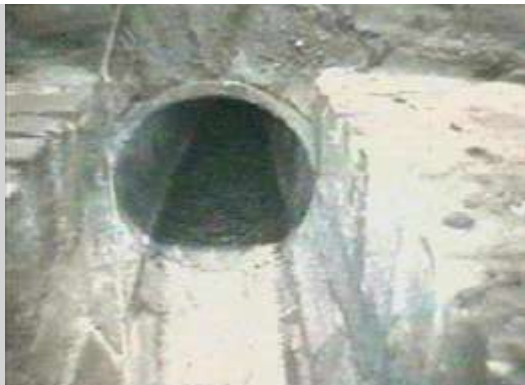
8 in. Circular Gravity Sewer Pipe In @ 6 O'Clock

Deposits: ☐ None ☒ **Mud** ☐ Sludge ☐ Debris ☒ **Grease**

Infiltration: **Evidence** Pipe Seal Cond: **Unknown**
